# PROPERTY INSPECTION REPORT

**ADDRESS:** 123 Live Oak Street Anytown, TX  
**PREPARED FOR:** John and Mary Sample  
**BY:** Gary Thompson  
Professional Real Estate Inspector  
TREC #5414

**CONCERNING:** 123 Live Oak Street Anytown, TX  
(Address or Other Identification of Inspected Property)

**BY:** Gary Thompson, TREC Professional #5414 4/23/2010  
(Name and License Number of Inspector) (Date)

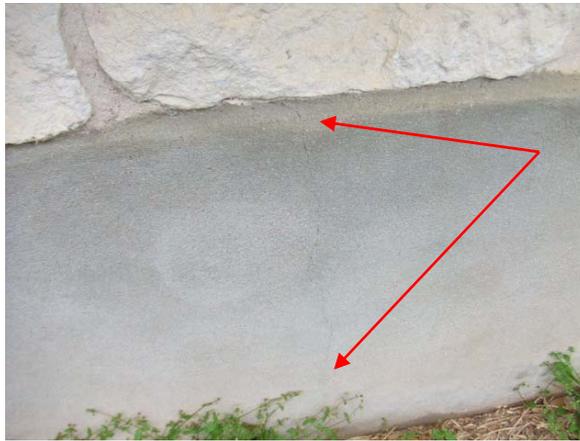
- The foundation appears to be functioning normally. Some hairline cracks were noted in the skim coat on the perimeter of the slab. These do not appear structural in nature.

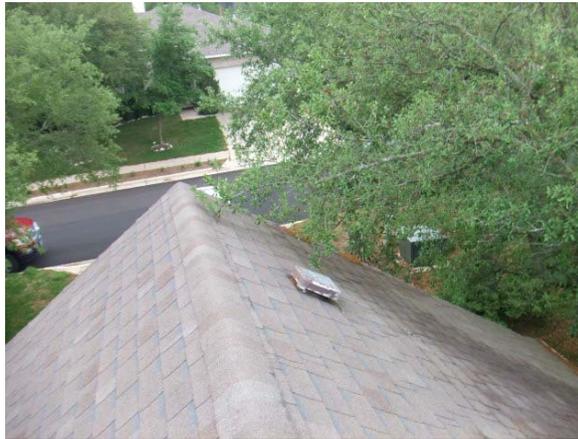
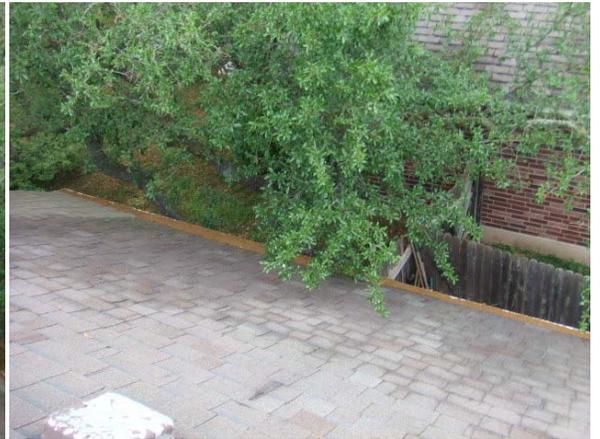
- Tree limbs are touching the front left part of the roof. They have scraped some shingles. The limbs should be kept trimmed back away from the roof surface.

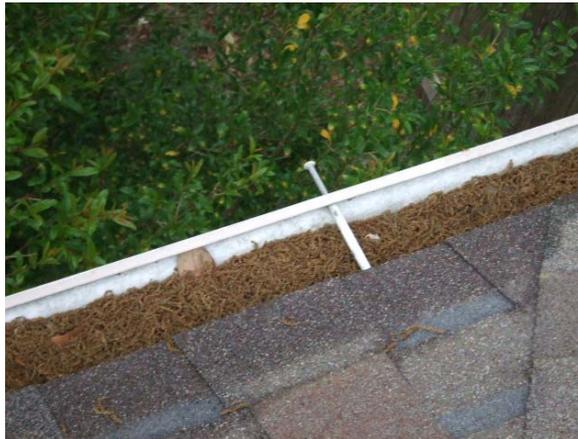
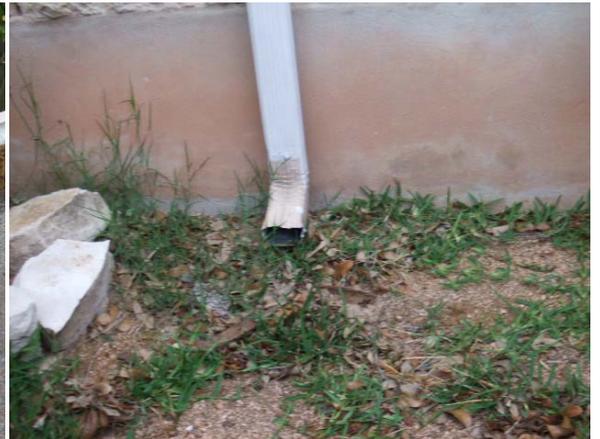
- Gutters are clogged with debris and should be cleaned out.
- A gutter spike has backed out at the back right corner of the house.
- Splash blocks are needed to improve site drainage and to keep water away from the foundation.

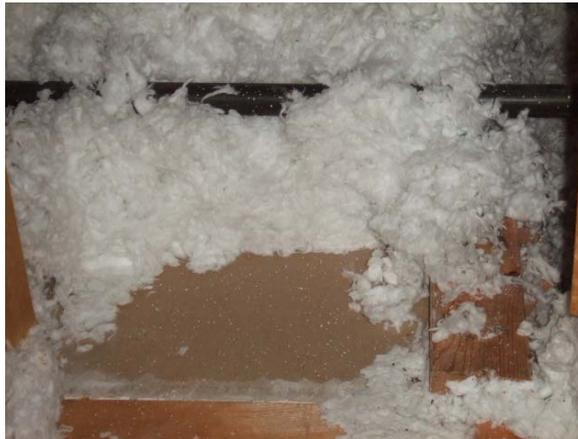
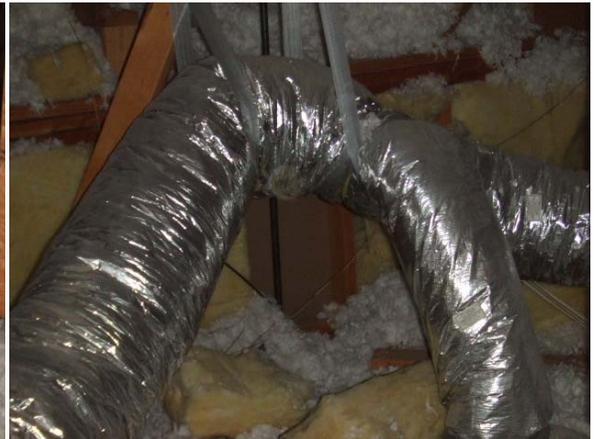
- There are a couple of small bare spots where blown-in insulation is needed.
- Vertical batts have fallen down or are missing at some areas in the attic.

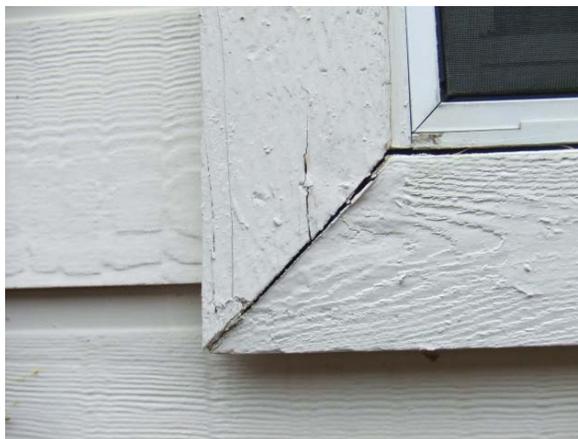
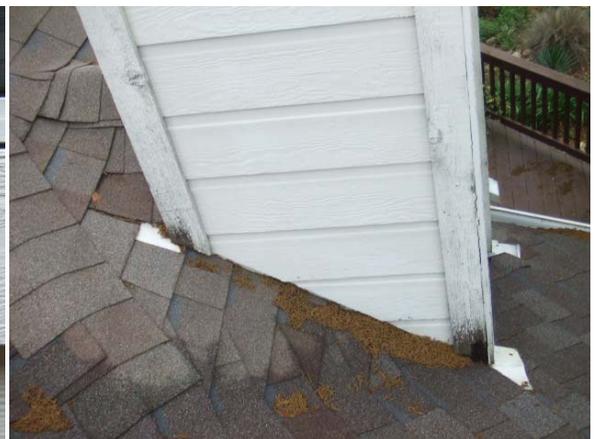
- Shrubs should be trimmed back away from the exterior walls.
- Joints have opened up on some of the exterior trim. Maintenance is needed.
- Trim on the chimney above the roof line is deteriorating and in need of maintenance.

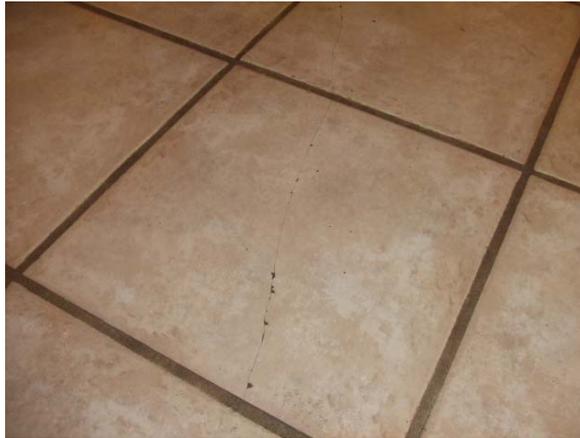
- There are several cracked floor tiles in the entry area. These appear to be from faulty installation of the tile and not a structural issue.
- Some typical hairline tape joints were noted on ceilings. These appear to be cosmetic in nature.

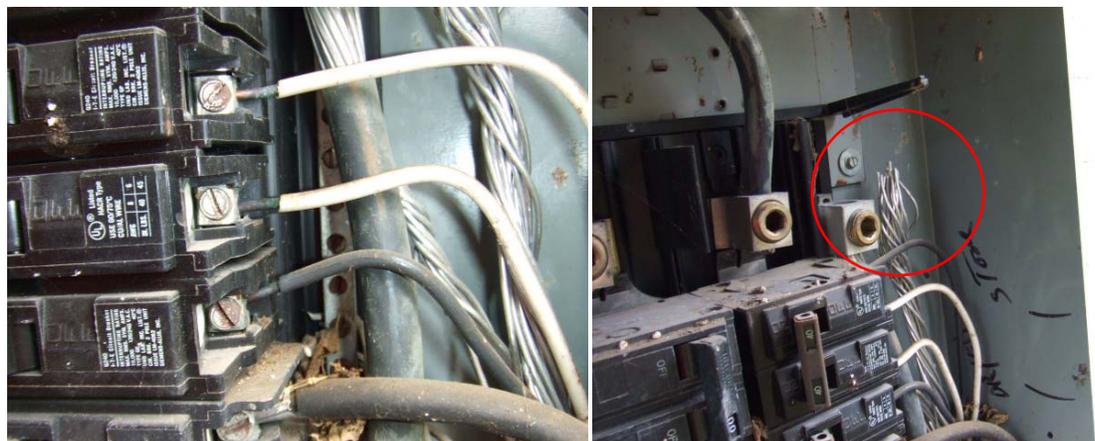
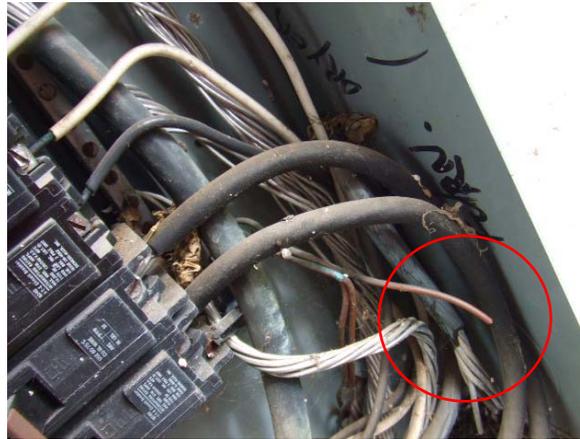
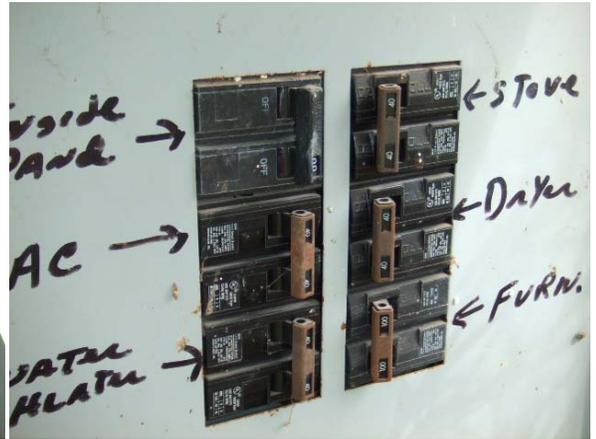
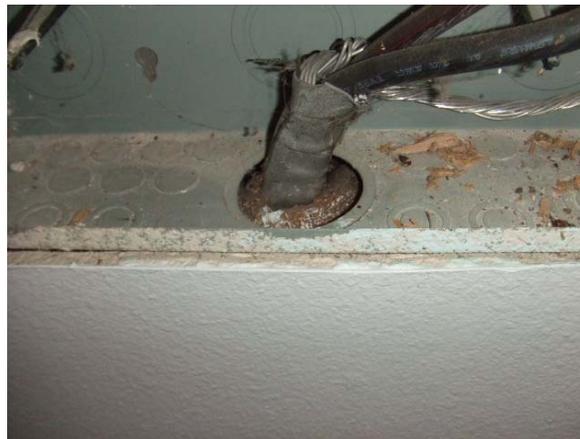
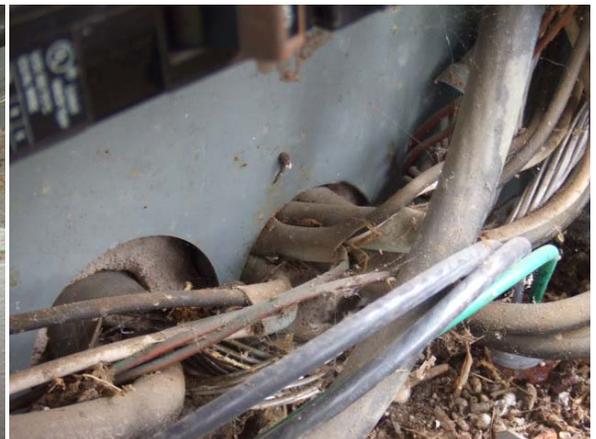
- The main panel is on the exterior. There are three 40 amp breakers in this panel with what looks like #10 copper wire attached. #10 copper is appropriate for use with a 30 amp breaker and is too small for a 40. This is a hazard as the breakers may not trip if needed. Two of these 40 amp breakers are labeled as for the dryer and water heater which usually only require 30 amp circuits. The condenser is marked for use with a maximum breaker size of 30 amps but a 40 amp breaker has been used. There

are several open ended wires in this panel. They should be capped or removed if not in use. Some of the exposed ends of the copper wires are blackened. This may be from overheating or may just be due to exposure and should be further evaluated by a licensed electrician.

- There is a subpanel in the front right bedroom closet. A clothes closet is considered a hazardous location for a subpanel. Easily ignitable materials should not be stored near a panel. Breakers in this panel are not labeled. Subpanels should be fed by four wires and be wired with the ground and neutral wires on separate buss bars. They are mixed together on the buss bars in this panel.

- Electric cable sheathing is touching the metal panel housings where they pass through knockouts in both panels. Appropriate bushings should be used.
- An oxide-inhibiting compound should be used at all aluminum wiring connections. (Aluminum at 220 volt is OK).

- Arc-Fault Circuit Interrupter devices are not present. This house was built prior to the advent of this technology.
- Contact a licensed electrician for further evaluation and repair as needed.

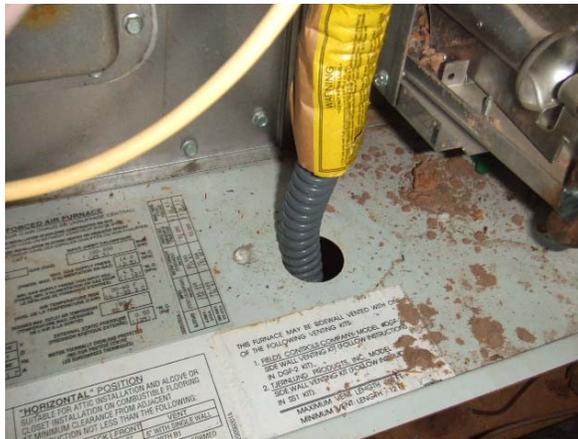
- The flexible gas connector is touching the metal furnace housing. A bushing should be added or the connector changed to solid pipe.

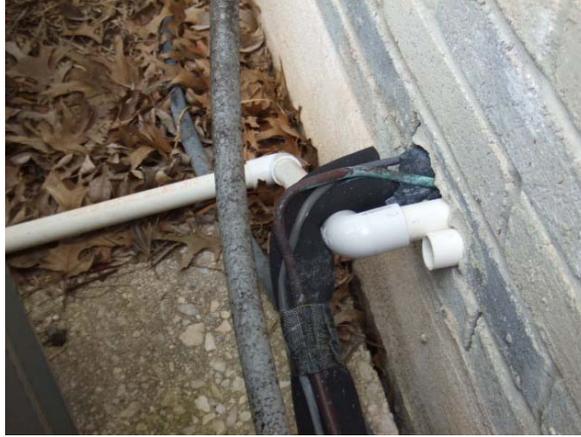
- The main condensate drain line in the attic should have a trap and should be insulated.
- Both the main and the secondary condensate drain pipes terminate by the condenser. It would be

better to have the secondary drain pipe running to a more conspicuous area so that dripping from this pipe would be obvious.

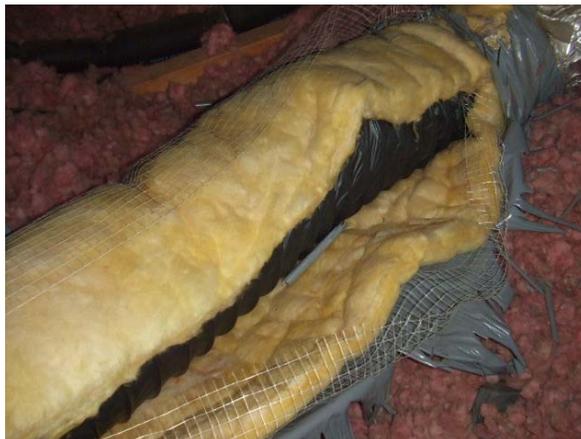
- The outer plastic vapor barrier is deteriorating from some of the air ducts in the attic due to UV damage or defective materials (note that most of the ductwork appears to have been replaced but there are still a few runs of bad ductwork). This will lead to a lack of proper insulation and the system will be less efficient due to sweating. Additionally, conditions will be conducive to mold and mildew growth in ductwork.
